SimpliCT® clinical case report: Osteoid osteoma RF ablation

Destruction of osteoid osteoma inside vertebra using ablation. Philips C-arm flat panel detector, Philips Xperguide software and SimpliCT used for navigation.

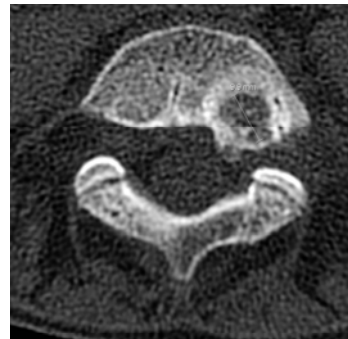
Osteoid osteoma seen in the vertebra

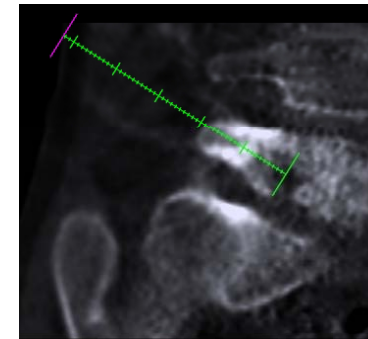
Sagittal plane planning

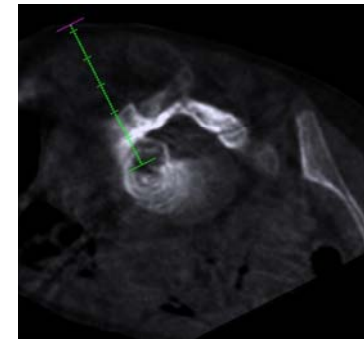
Transverse plane planning

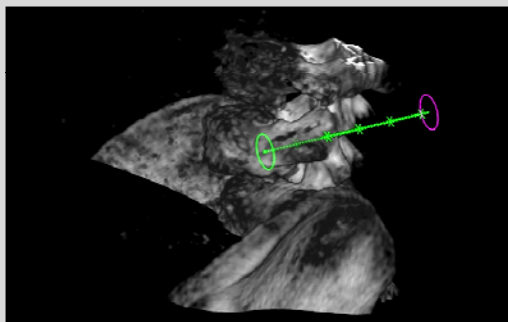
3D planning of the needle trajectory

XperGuide together with SimpliCT are able to place a needle onto the lesion. The skin entry point was found. The needle was drilled into the planned needle angulation using SimpliCT. The progression of the needle was visualized using the C-arm in progress view. The tumor was hit by the needle, and destroyed with RF ablation.

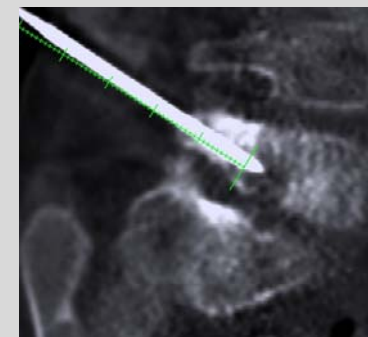
Sagittal plane after insertion of needle.

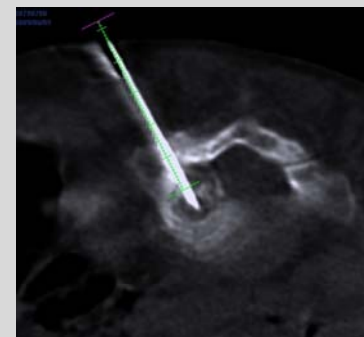
Transverse plane after insertion of needle.
